AFML-TR-66-310
PART V
VOLUME III

The work presented in this volume is concerned with the performance prediction, testing, and post-test evaluation of a representative graphite-fiber, resin-matrix aircraft fuselage component. Additional material properties were determined and structural margins of safety defined by discrete element analysis. After seven response tests under various load combinations, the component was tested to destruction under combined bending and shear loads. Failure occurred at 110 percent of the target design load but below the failure load predicted from tests on flat panels. A weight saving of 27 percent over an aluminum structure of equivalent strength was demonstrated. The component was also three times stiffer than an aluminum structure of the same weight. Performance projections indicate that the same component built with presently available "Thornel" 50S fibers would offer a weight saving of 49 percent. Post-test evaluations included tensile and compression tests on curved skin panels, on stringers, and on stringer-skin combinations. Optical and electron microscopic examination of the fracture surfaces provided further insight into the failure mechanism

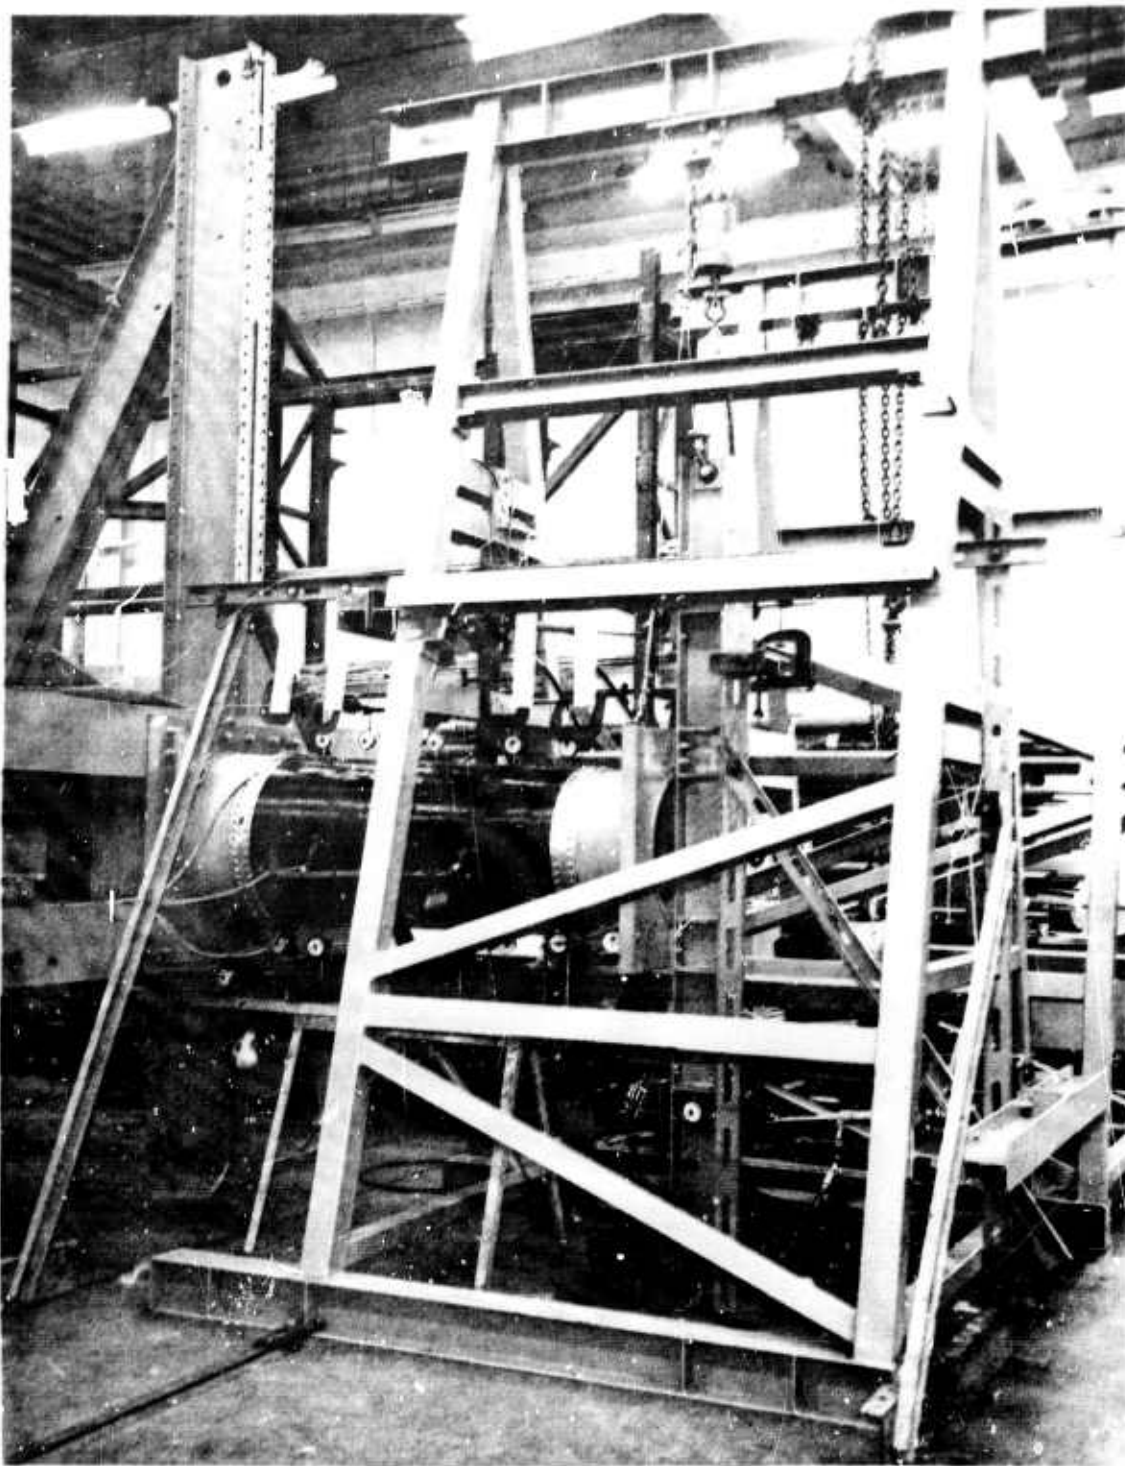
P700068

Figure 1. Fuselage Component in Test Stand.

Prior to the planned response tests, check-out tests were conducted to verify proper operation of the test facility, set-up, and instrumentation. Figure 1 shows the component mounted to the steel frame back-stop and the A-frame loading structure. Three preliminary tests were conducted as summarized in Table I.

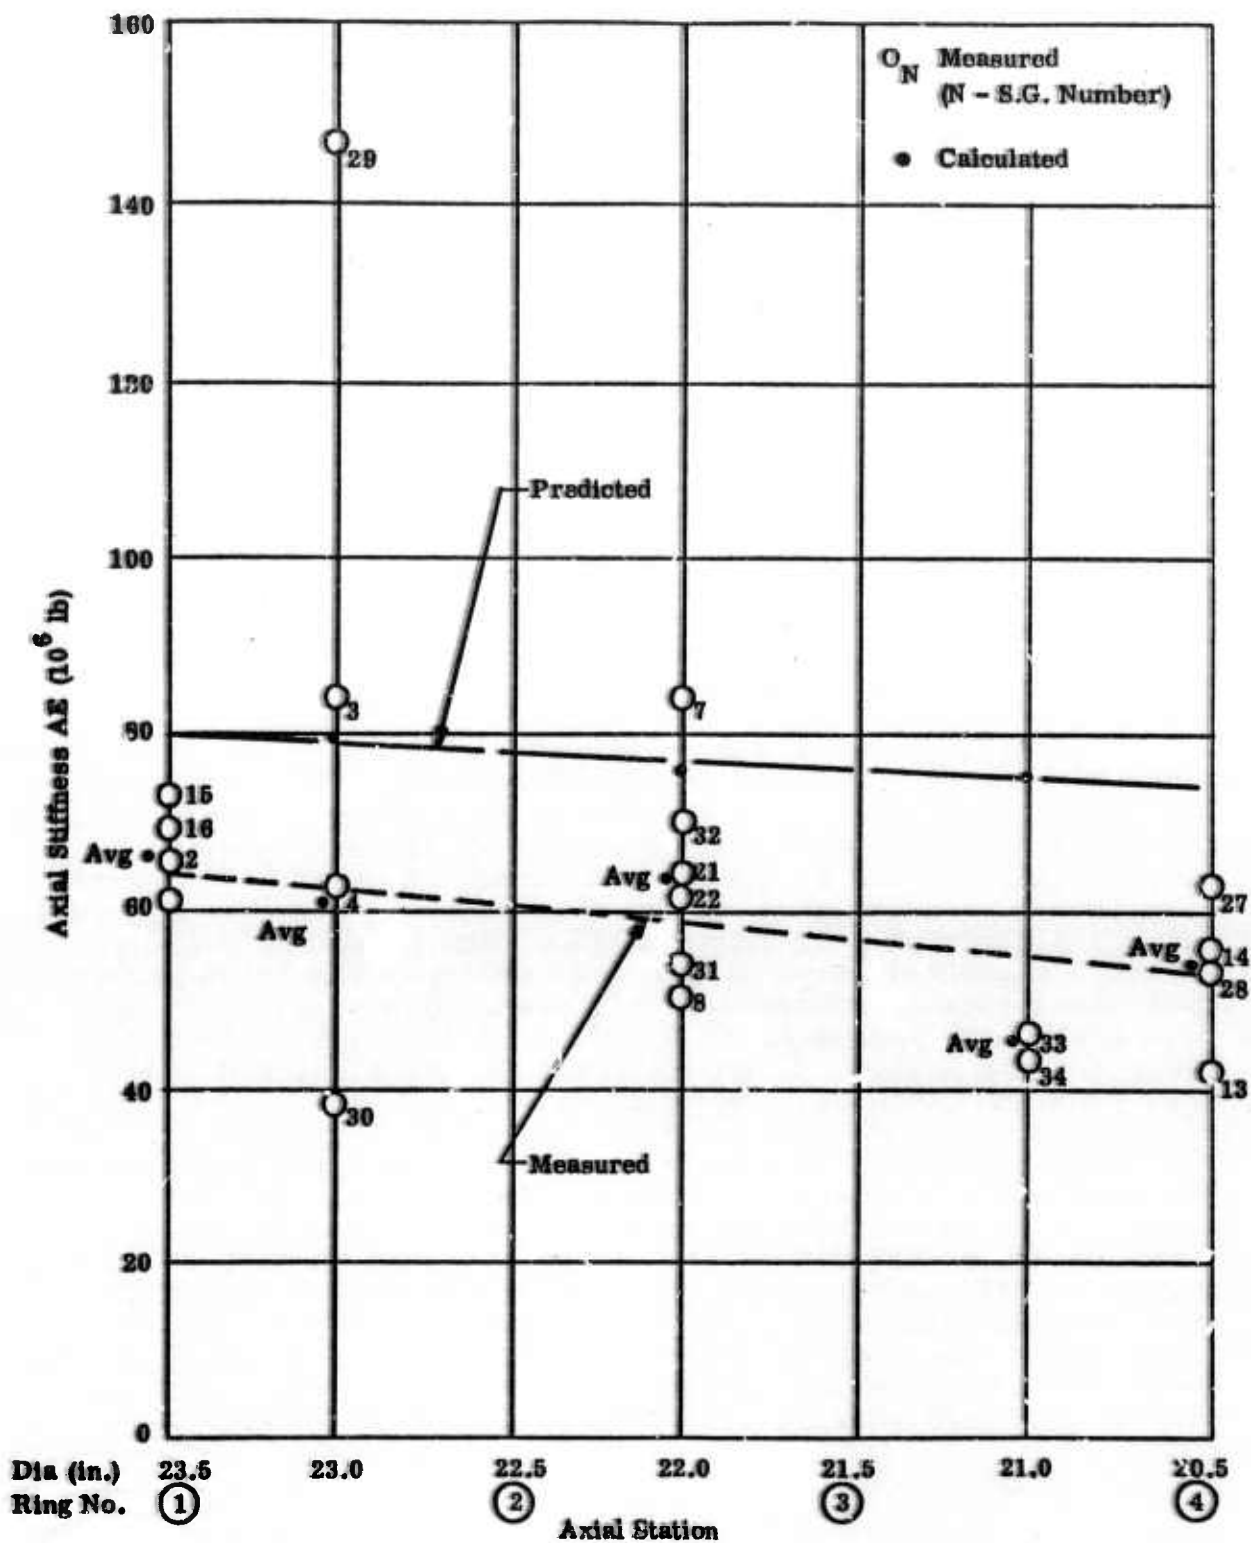
Figure 2. Axial Stiffnesses from Preliminary Test 2

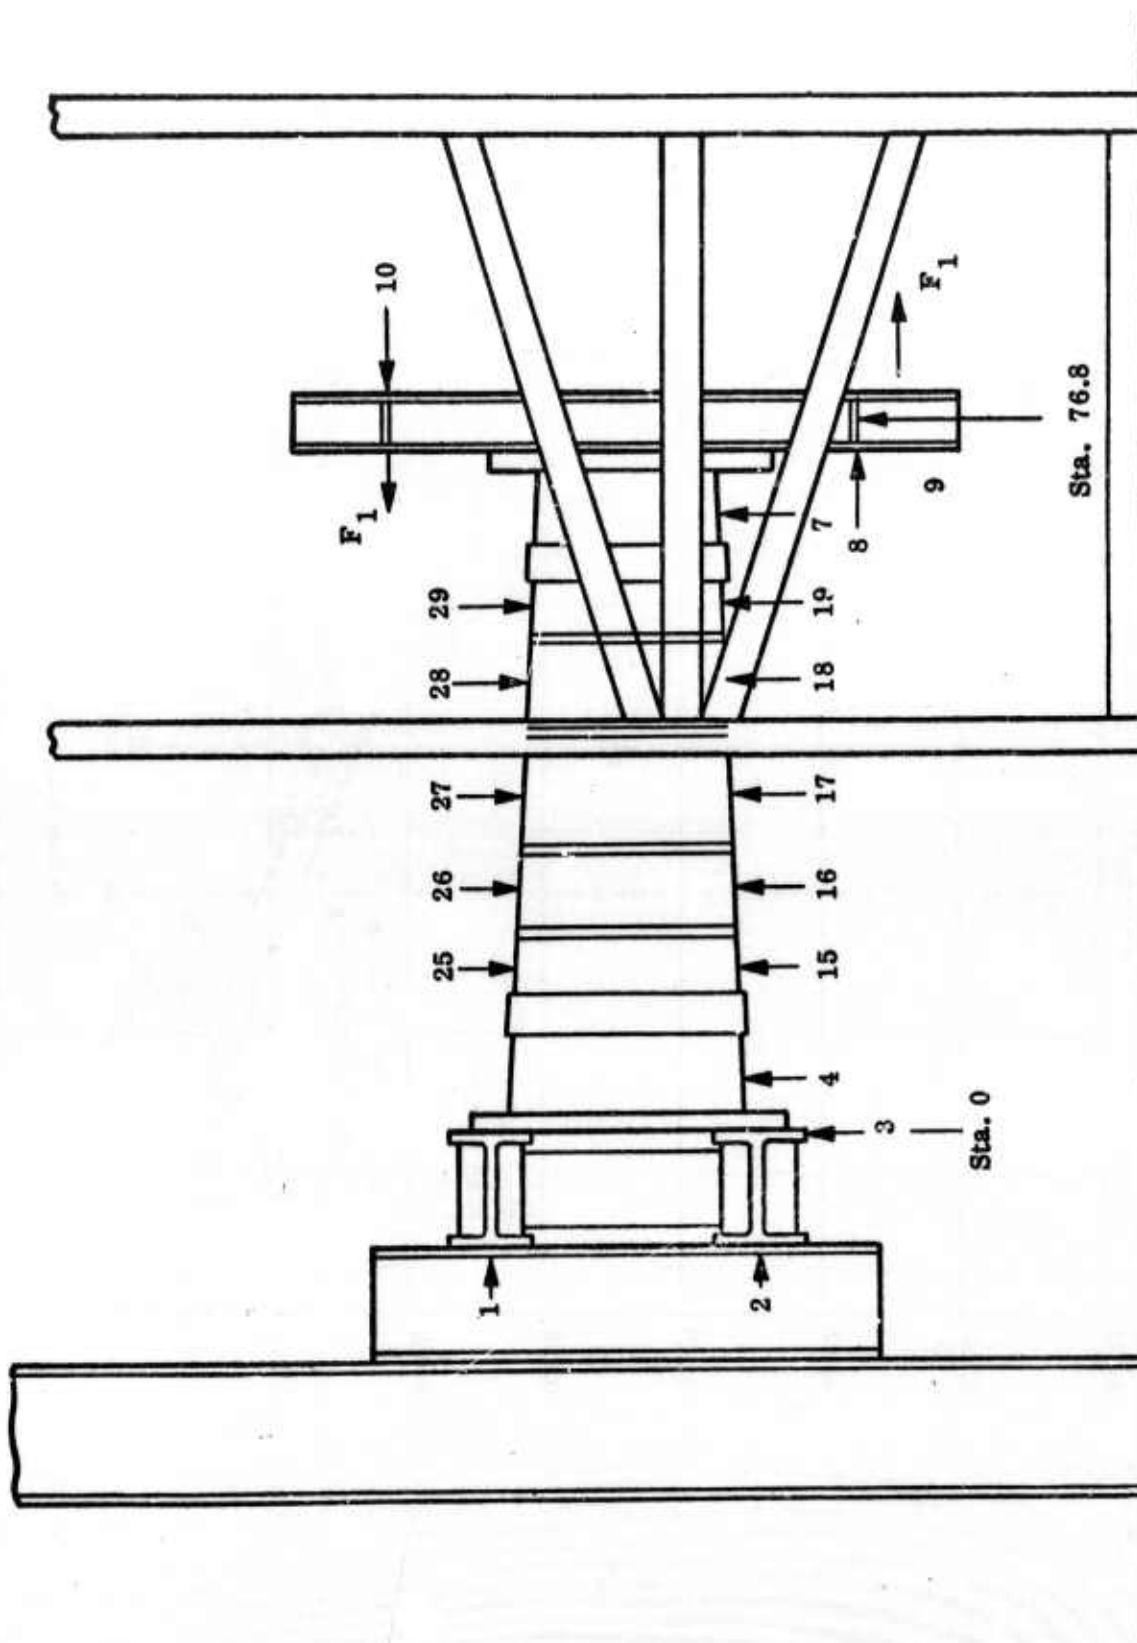
Figure 3. Dial Indicator Positions for Preliminary Test 3

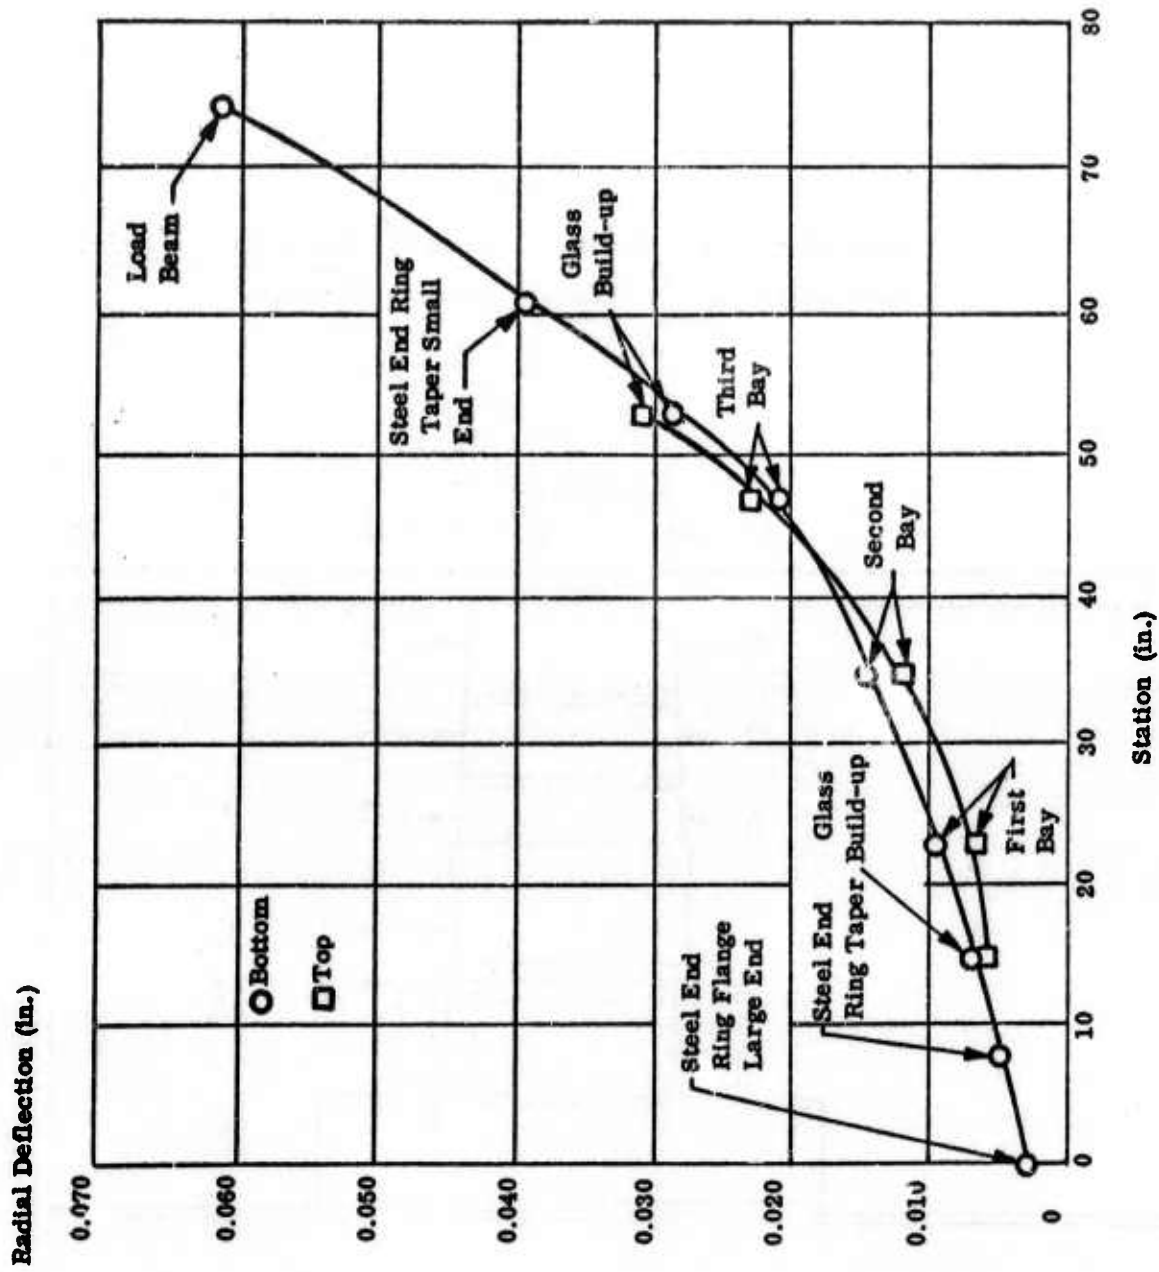
Figure 4. Radial Deflections from Preliminary Test 3

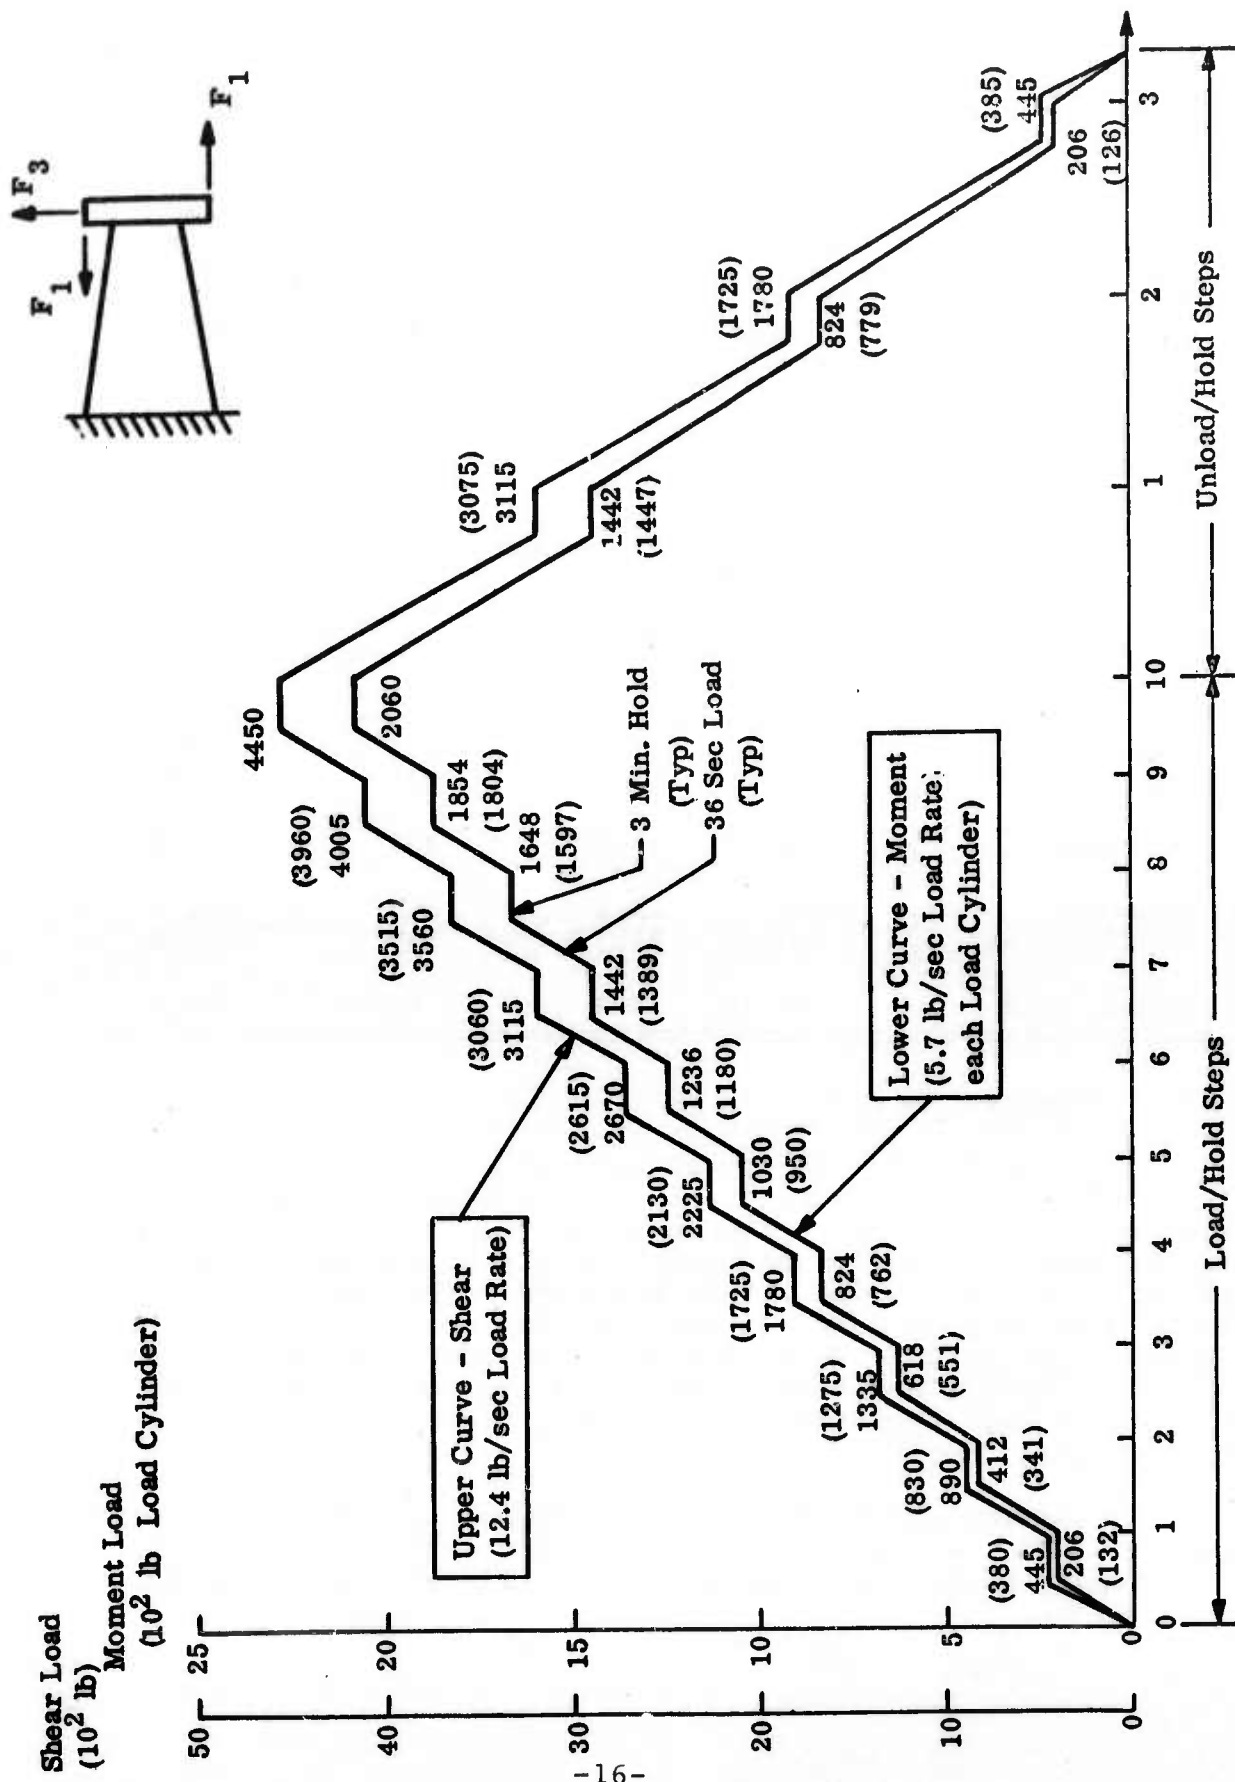
Figure 5. Response Test 1 Load Profile

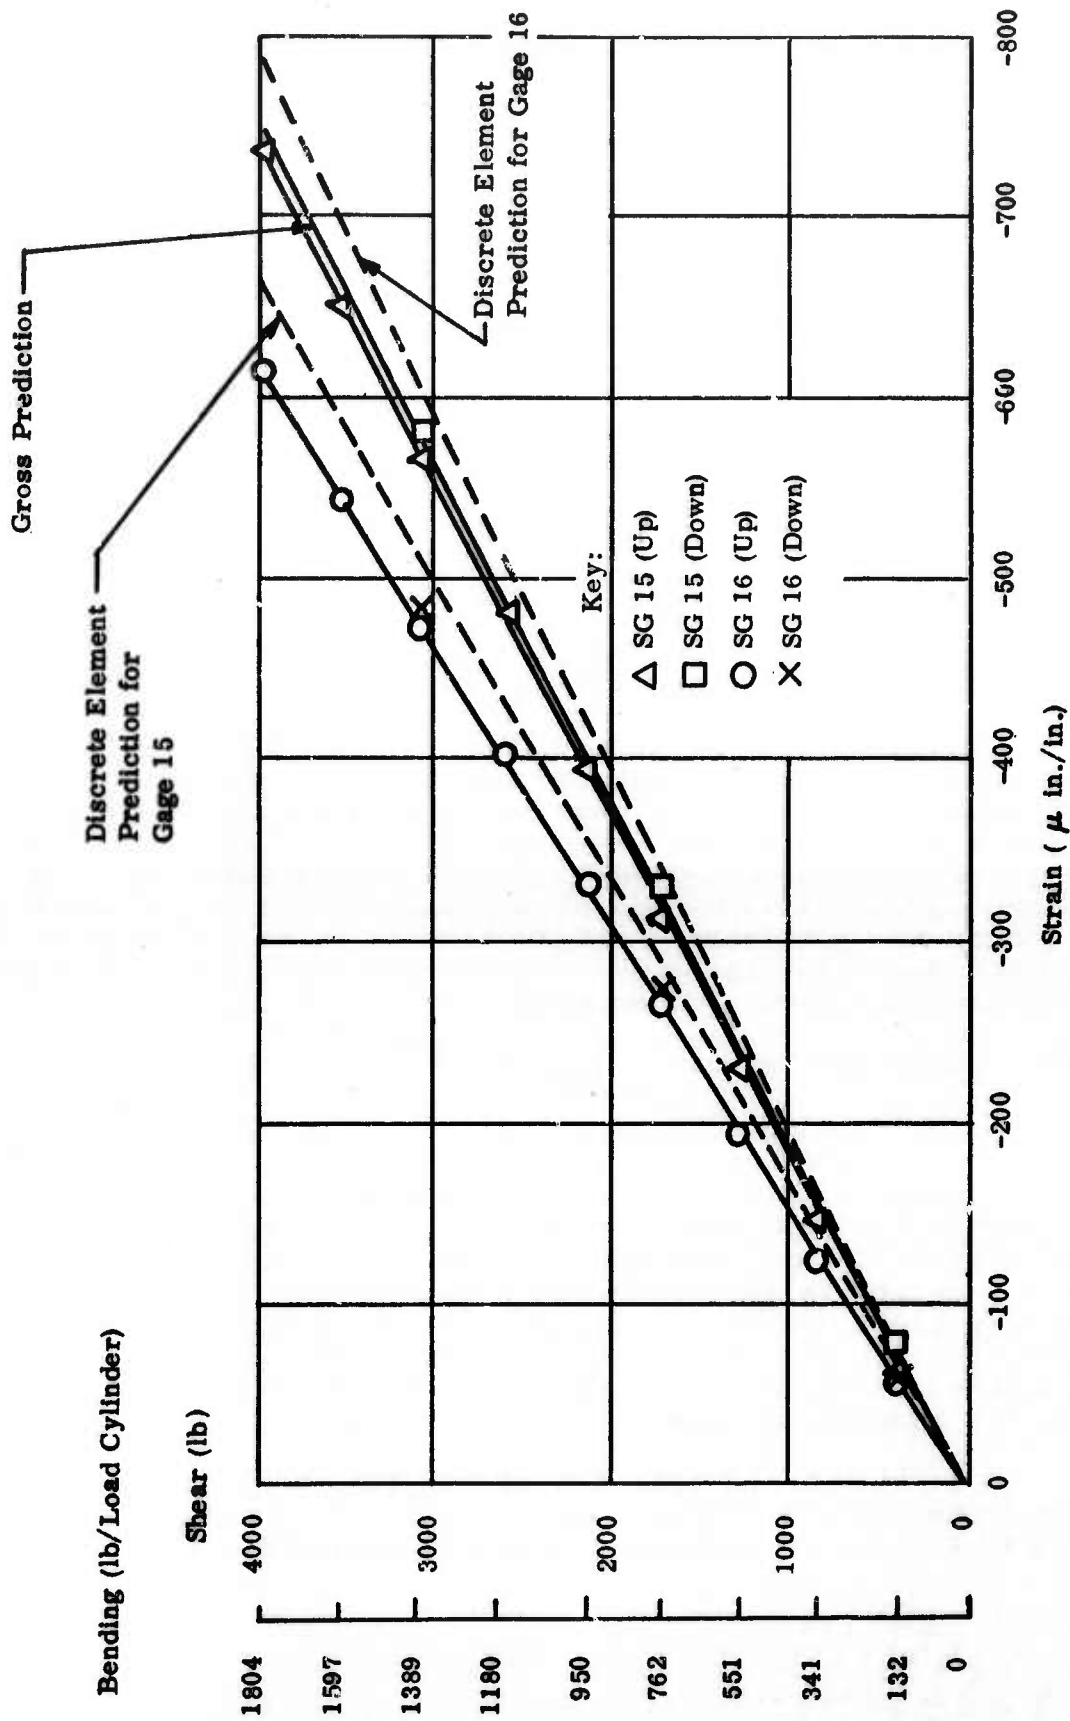
Figure 6. Typical Load-Strain Curves from Response Test 1

A typical plot of load level versus predicted and actual strains is shown in Figure 6 for strain gages 15 and 16 (15 on skin at top in large end mid-bay, 16 on stringer cap at top in

large end mid-bay). Discrete element and gross predictions are shown and agree quite well with actual values.

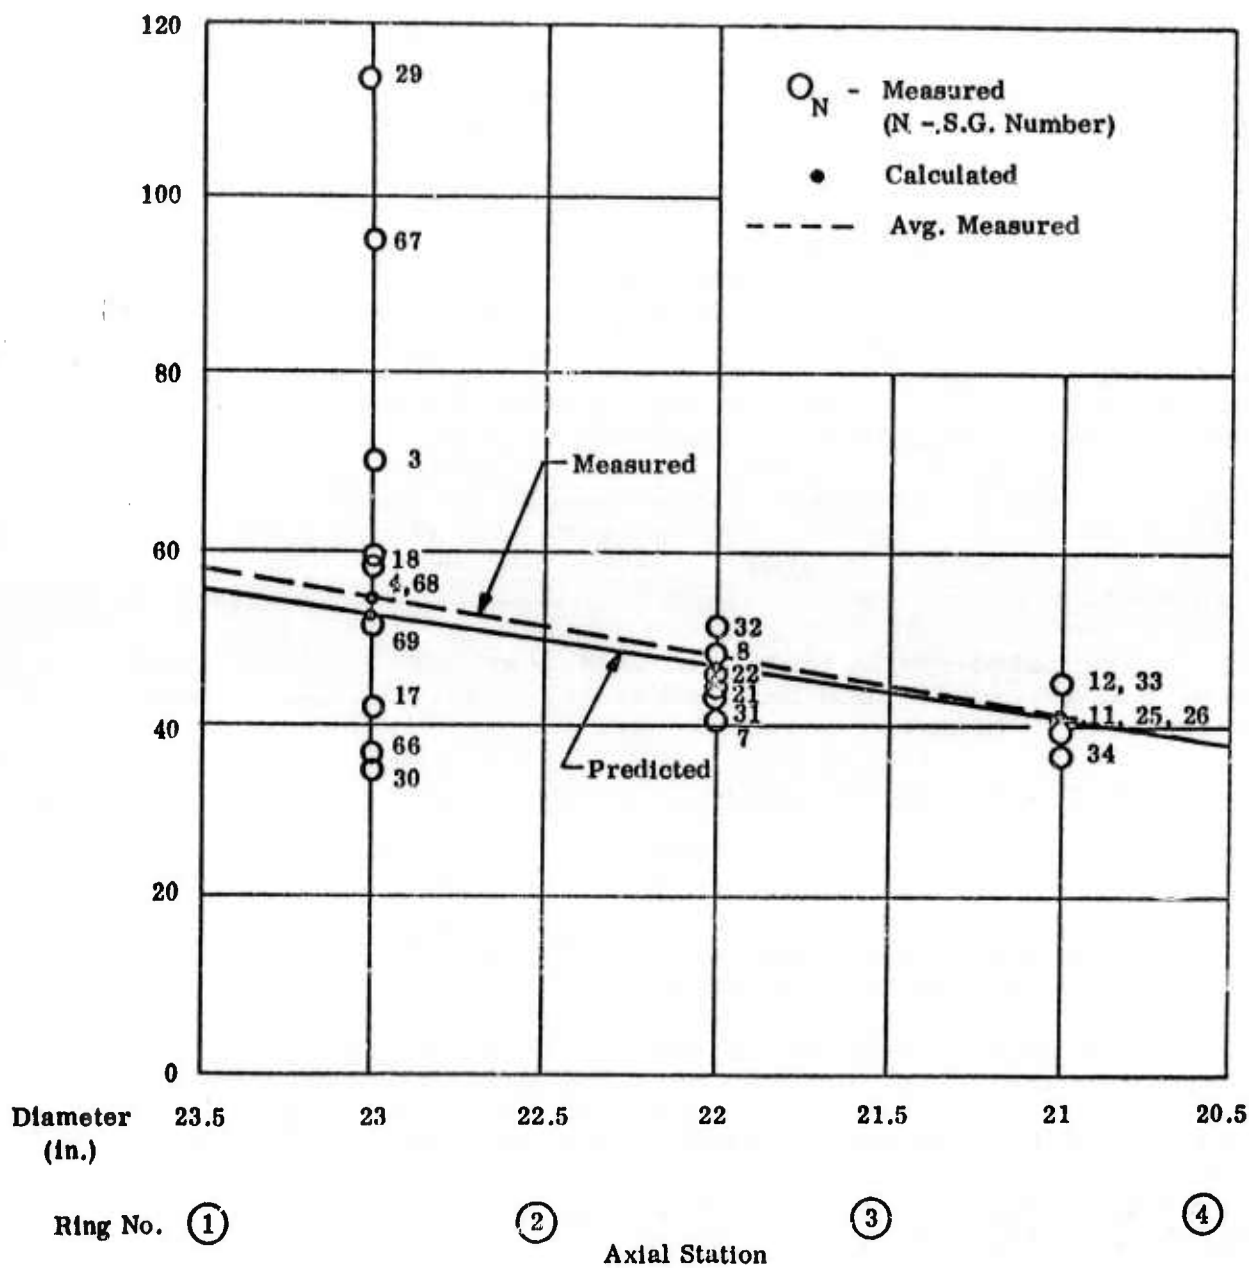
Figure 8. Flexural Stiffnesses from Response Test 1

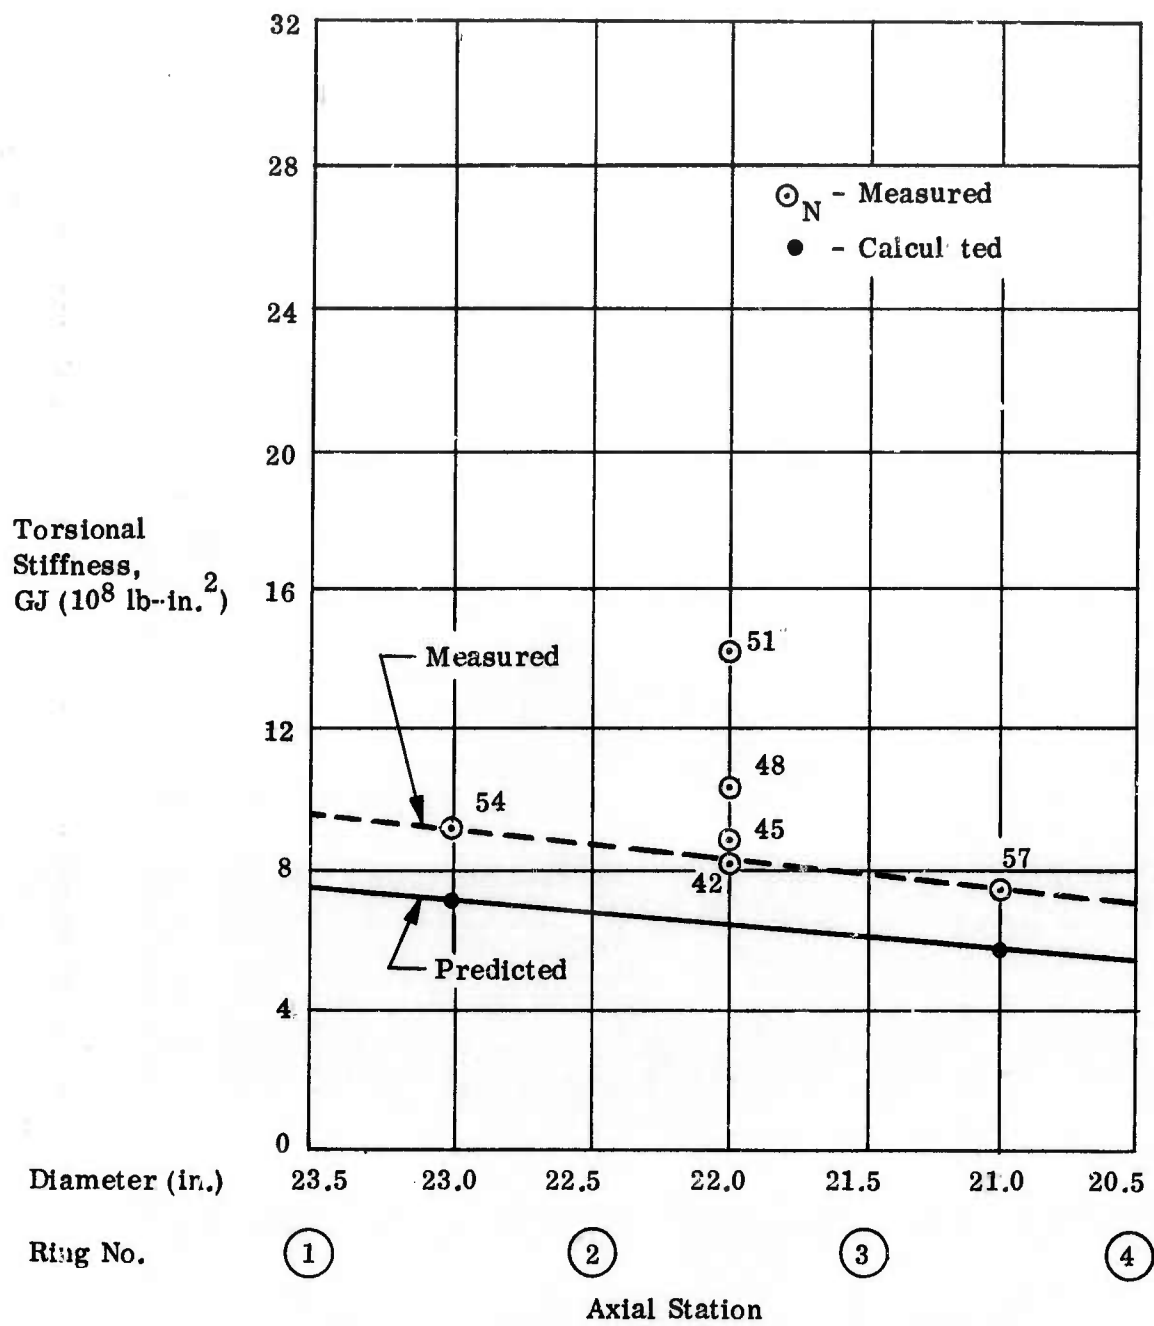
Figure 10. Torsional Stiffnesses from Response Test 2

shown in Figure 10 were 20 to 30 greater than predicted which is due to an unknown part of the torsion being carried by the stringers. Later in Section V A and shown on Figure 34, measured stiffness based on the 24 minute end rotation compared very well with predicted values.

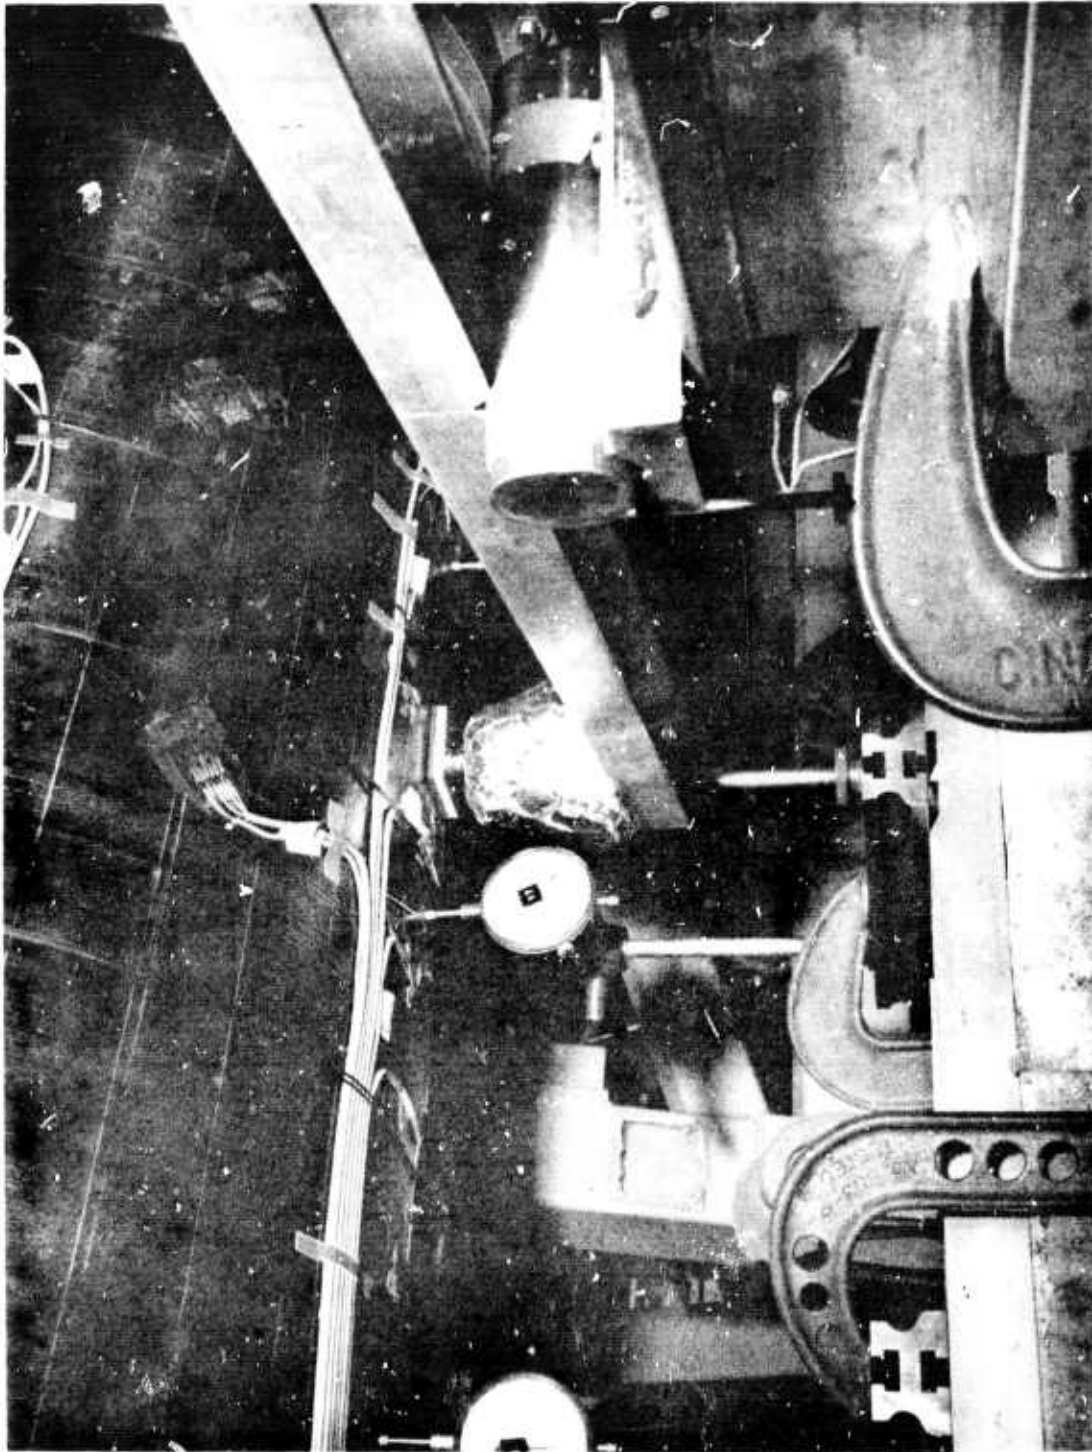
P700067

Figure 12. Close-Up of Response Test 4 Local Load Application.

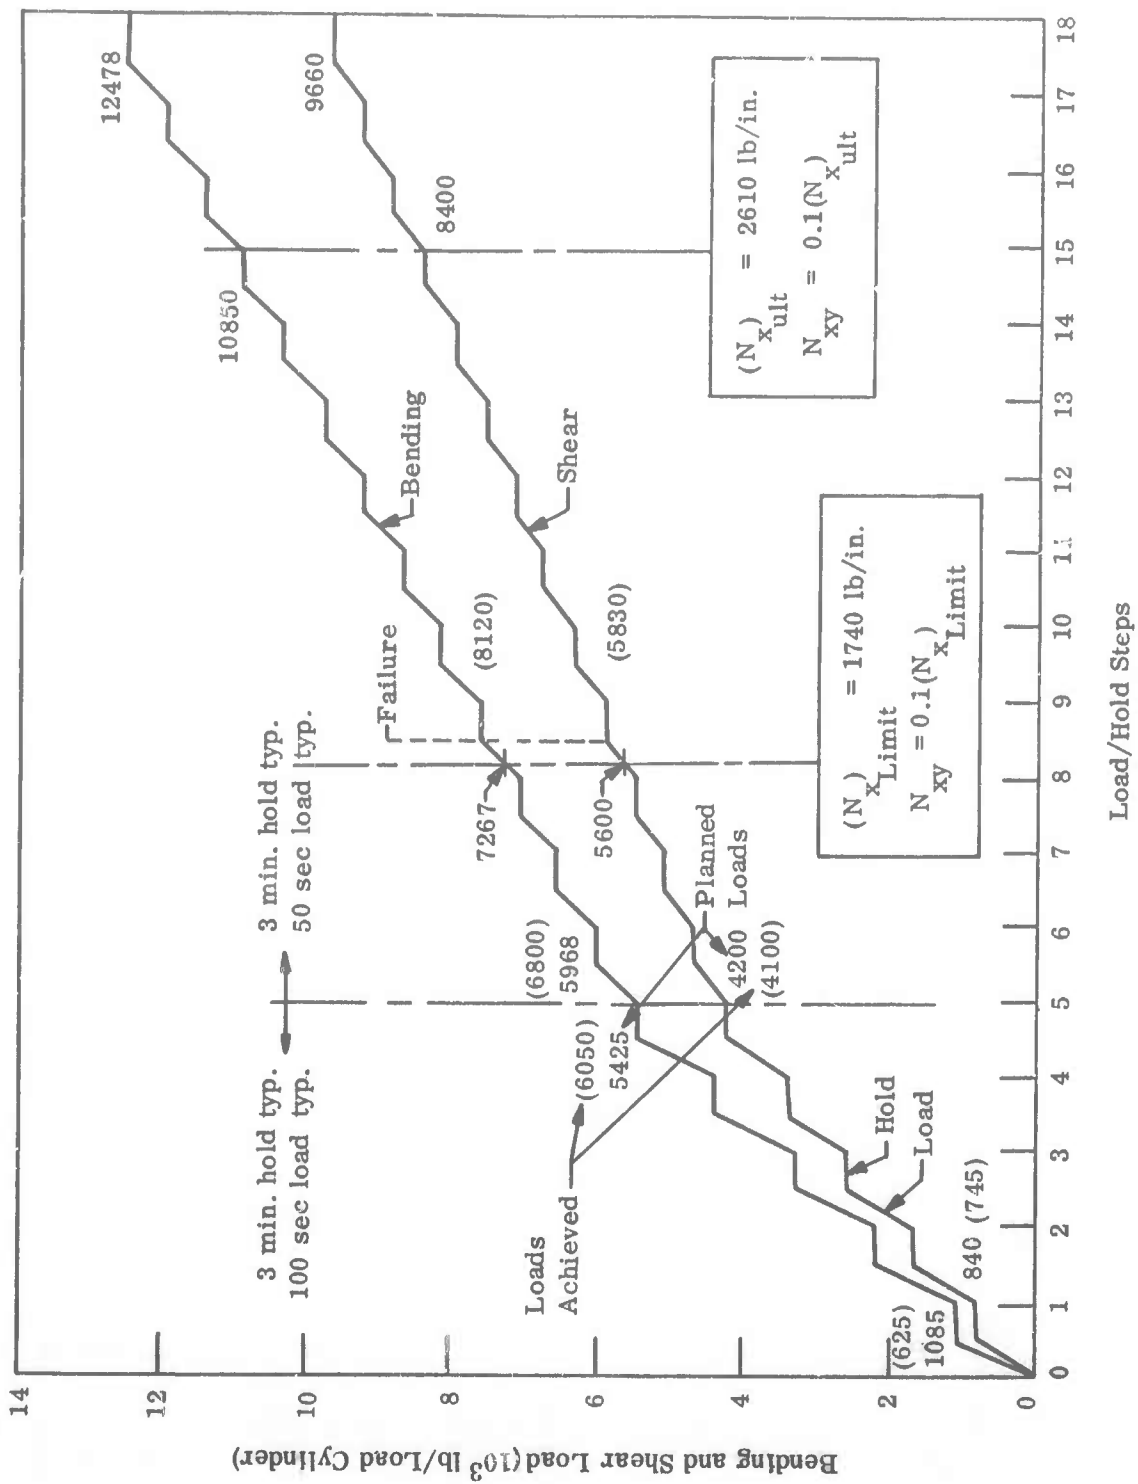
Figure 15. Destruct Test Load Profile

As shown in Figure 15, failure occurred upon reaching load step 9. Maximum bending load at failure was 1980 lb/in. or 110% of the 1800-lb/in. design requirement. It was, however, only 76% of the expected 2610-lb/in. ultimate load. The fuselage component carried a shear load at failure of 200 lb/in., or 10% in excess of the 180-lb/in. design requirement for shear. Film coverage established that failure originated at the bottom of the component (tensile side) and progressed up to the top. The general plane of failure (Figures 16 and 17) was at ring frame 2.

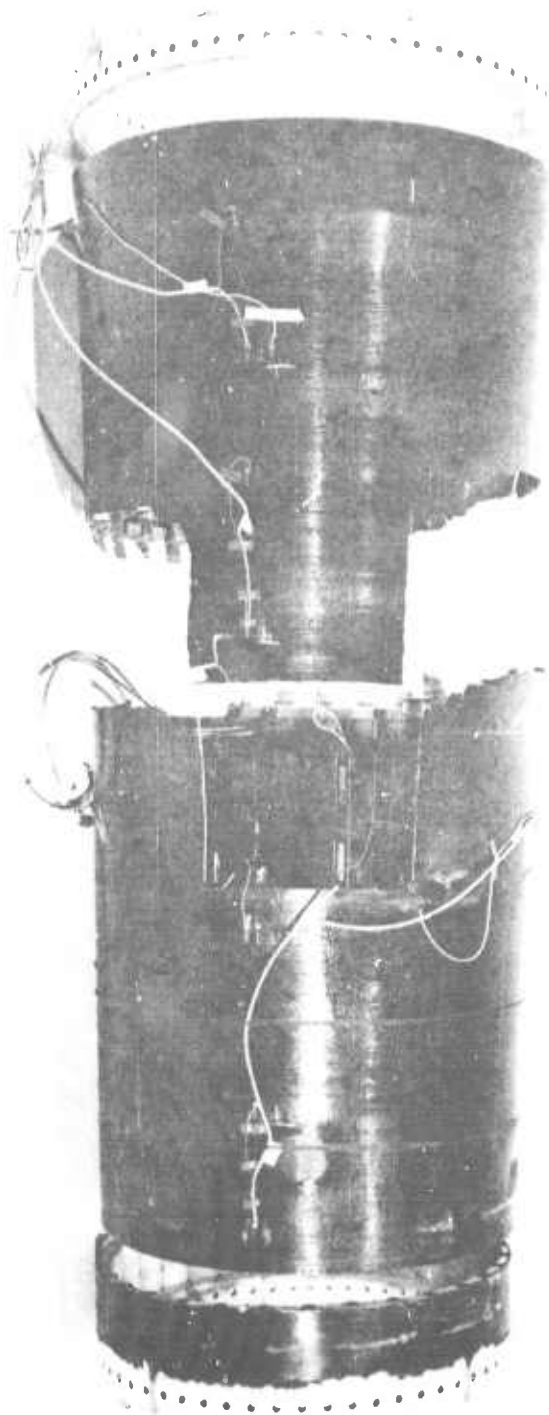
Figure 17. Top View of Failed Component (Shown After Cutting
"Tongue" and Sawing Off End Buidlups) P00069

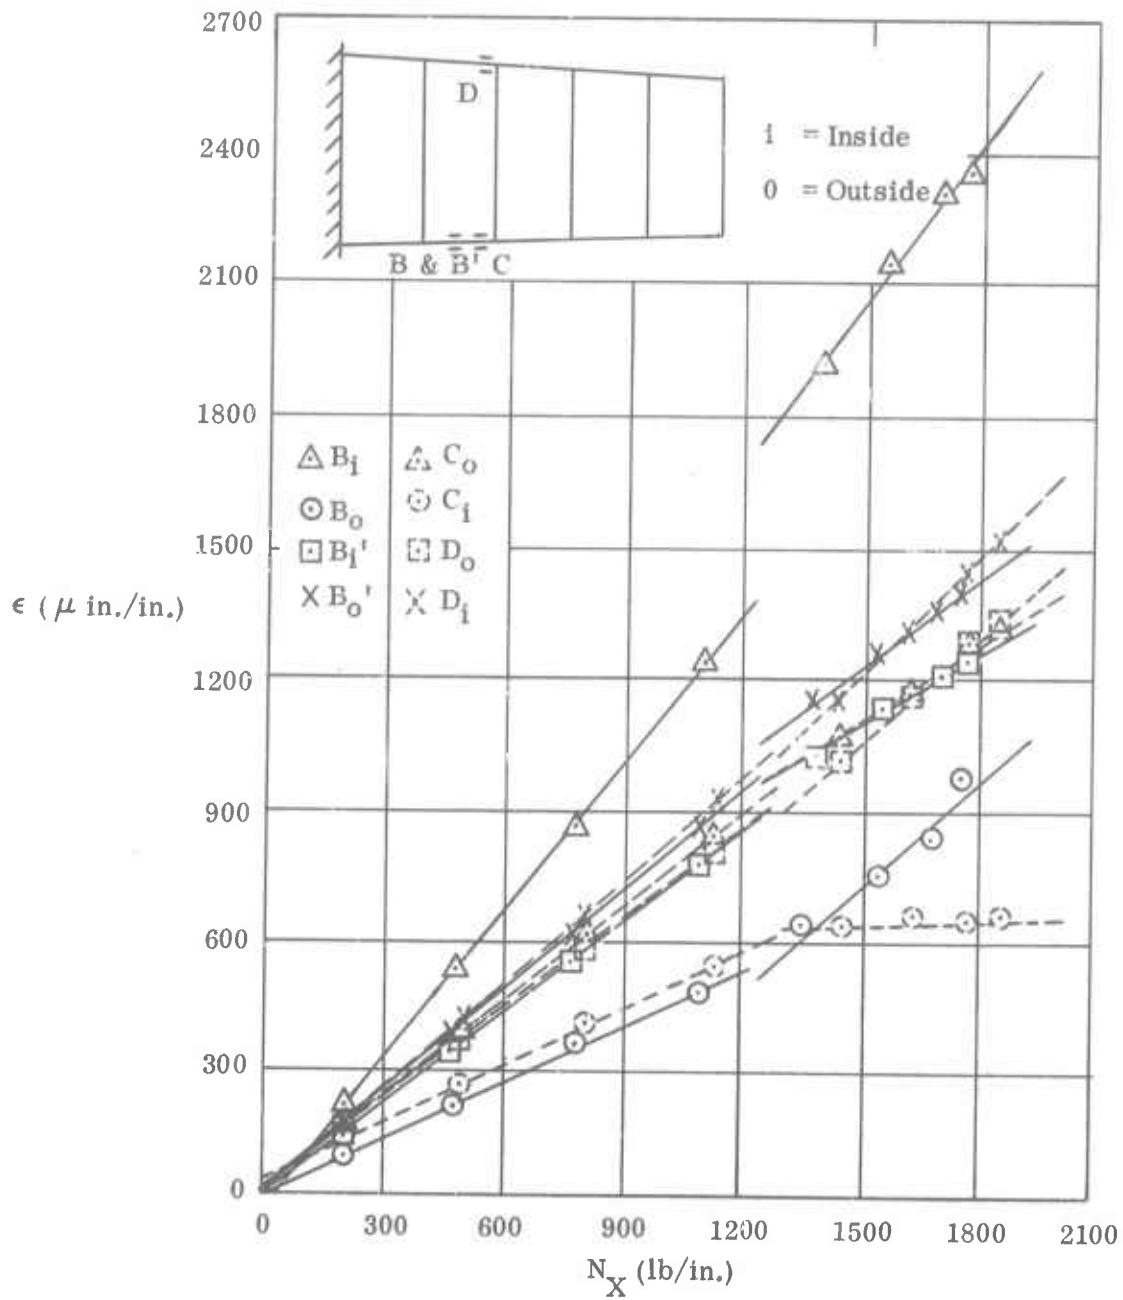
Figure 18. Strain-Load Curves from Destruct Test

Practically all gage outputs showed some evidence of a little jiggle at load Step 4 as shown in Figure 18; however, away from the localized bending region, the curves were all very nearly linear. Load deflection plots, as well, were all linear. Belief that failure first occurred locally was therefore given further support. The failure load occurred upon reaching load Step 9 at 1980 lb/in. The curves shown in Figure 18 are extended to that measured load level since timing did not permit strain recordings.

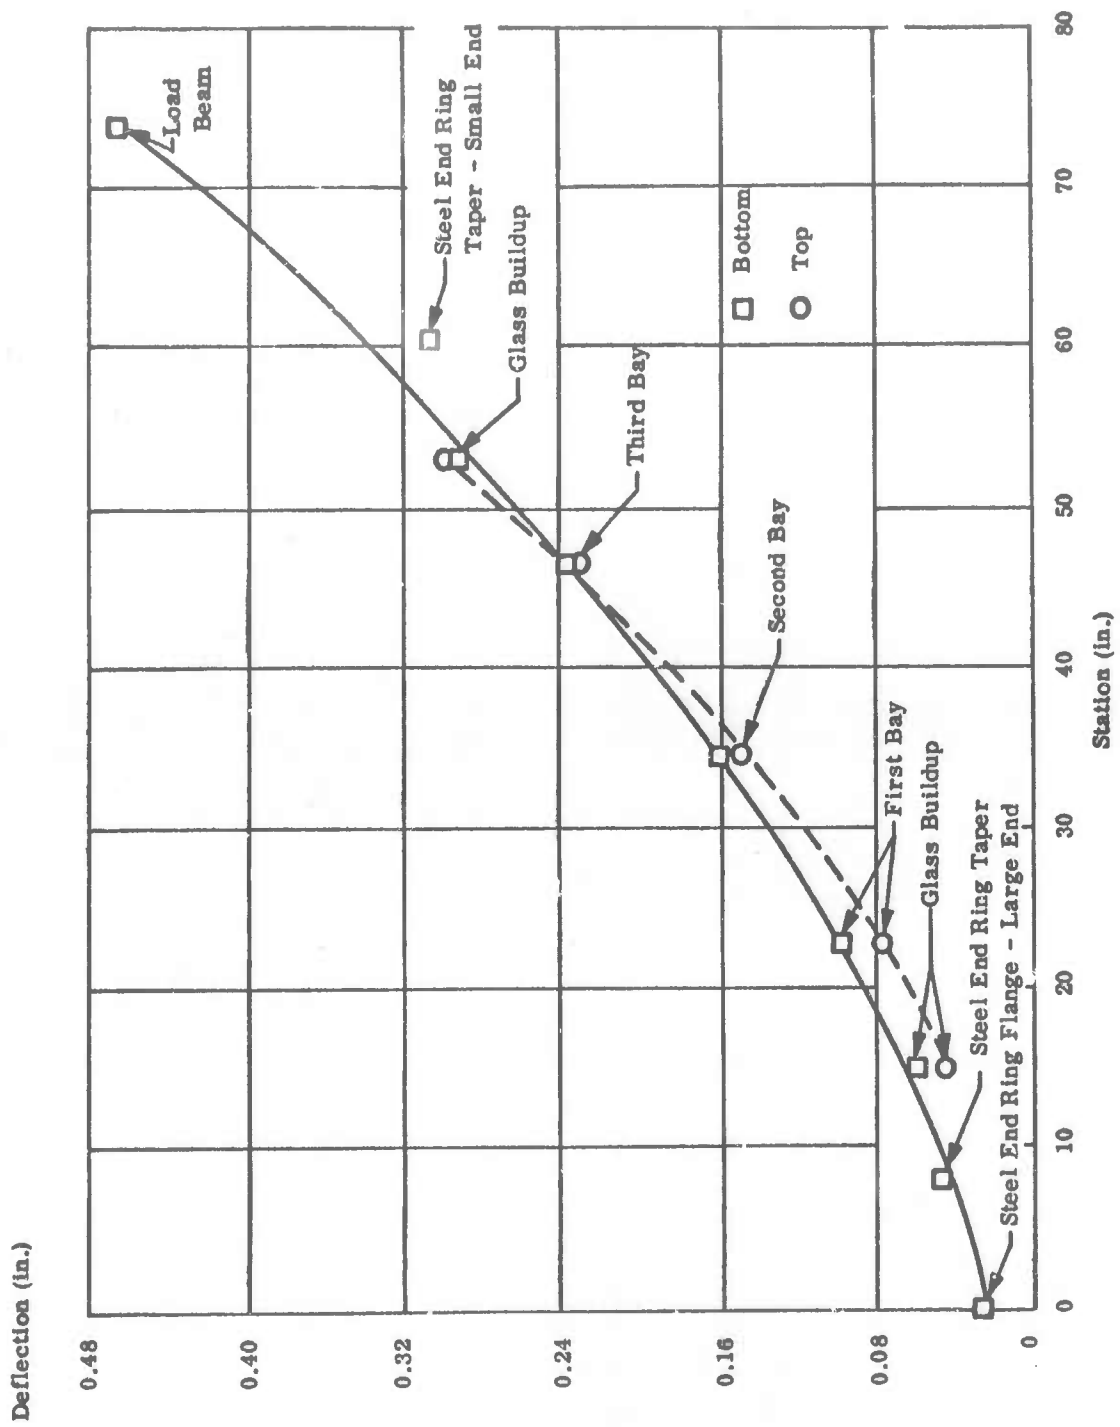
Figure 20. Destruct Test Deflections versus Axial Station
